## Seismic structural assessment of the Christchurch Catholic Basilica, New Zealand

**Keywords**—Basilica, Christchurch, Seismic assessment, FE modelling, Pushover analysis

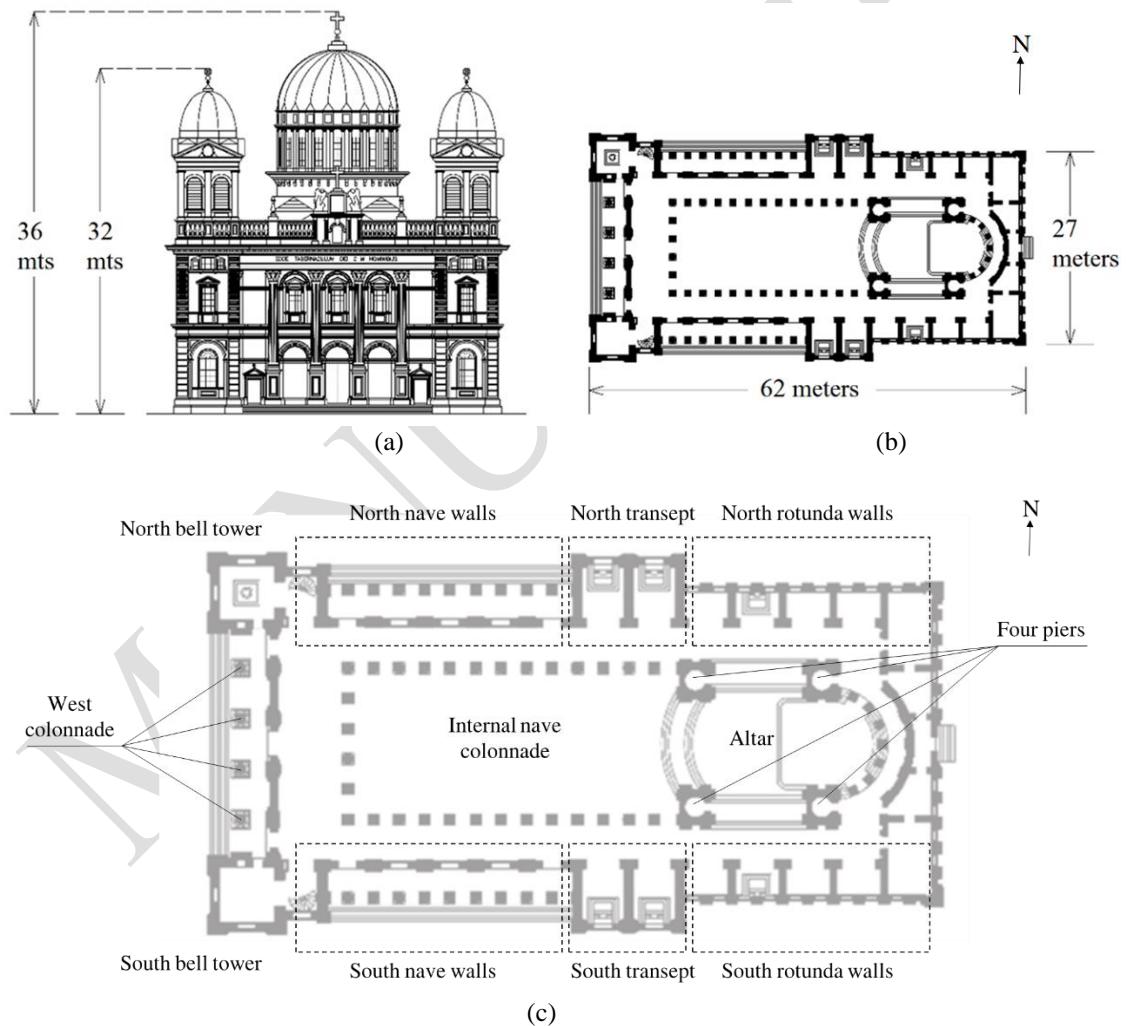
Fig. 2 – Geometry of Basilica of the Blessed Sacramento: (a) west elevation; (b) plan; (c) designation and location of important structural elements.

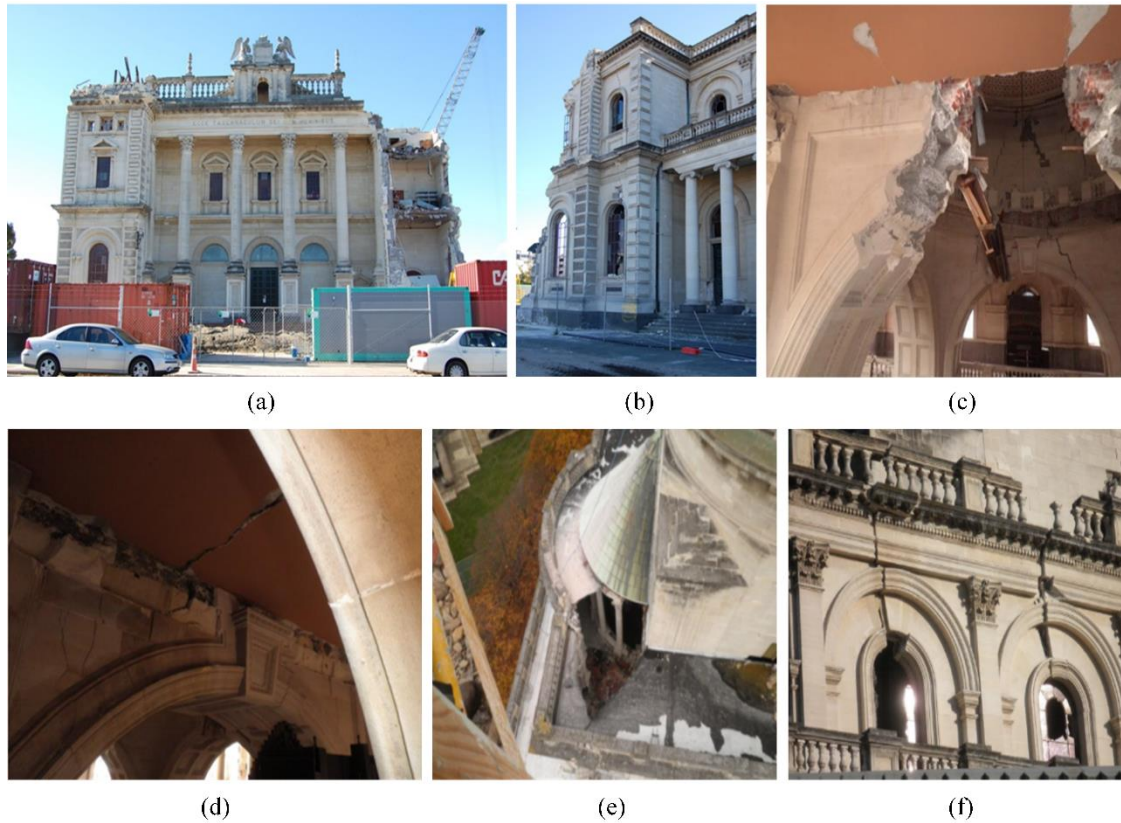
Fig. 3 – Observed damage in the Basilica after the February 2011 earthquake: (a) West façade, damage at the two bell towers; (b) Detail of the west wall collapse of the south bell tower; (c) Collapse in the north arch of the sanctuary; (d) Severe damage to the south arch spandrel; (e) Collapse of a part of the RC sanctuary flat roof; (f) Shear cracks around the upper arcade of the north elevation.

The most important damage observed after the seismic event of February 2011 is described as follows (Fig. 3) [33], [39], [42]: (i) damage at the north and south tower belfries, with collapse in the northwest and southwest directions, respectively; (ii) the north and south façades present severe shear cracking behind the bell towers, spalling of the ground piers (due to in-plane rocking), and high deformations and cracking around the windows and doors; (iii) cracking of the outward walls of the north and south transepts; the north wall had a shear crack around one window on the ground level, which is not significant compared to the south façade; (iv) significant damage at the main dome drum, as well as collapse of the supporting north arch and severe damage at the south arch; (v) in the two levels that include the sanctuary, below the Dome and Rotunda, some

concrete flat roof areas of the upper level (retrofitted in 2004) collapsed and present severe shear cracks.

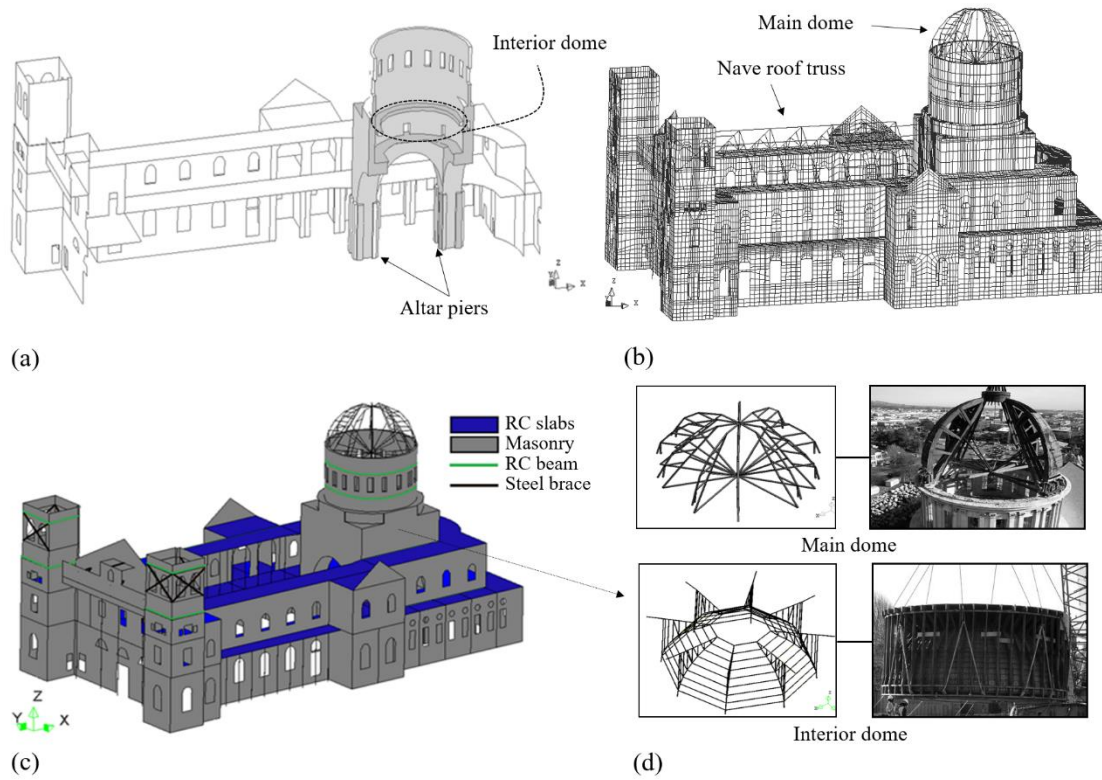
Fig. 4 – Three-dimensional model: (a) Shell and solid elements: west-east cut-away perspective with shell elements (coloured white) and solid elements (coloured grey); (b) Mesh discretization; (c) Description of the materials; (d) FE discretization of the main and interior dome.

ring beams added to the bell towers in the 2004 strengthening intervention. Note that the existing three-dimensional frames of the interior dome ( $5 \times 10 \text{ cm}^2$ ), the Basilica's main dome ( $10 \times 30 \text{ cm}^2$ ), and the nave roofs (diameter =  $10 \text{ cm}$ ) were also modelled using beam elements. It is noted that whilst the latter systems correctly represent the load paths, the claddings associated with these parts were not explicitly modelled. Instead, representative point masses (PT3T [31]) were computed for each node located at the top of these three-dimensional frames (nodes which receive the cladding self-weight) according to its tributary area (Fig. 4d.)

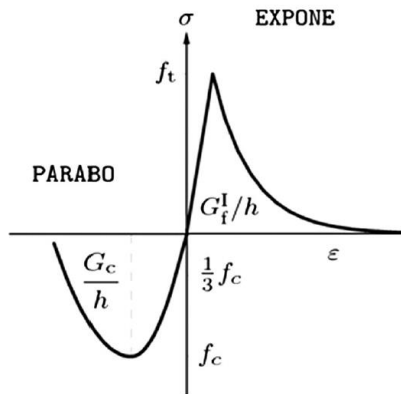
Fig. 5 – Stress and strain curves for the tension and compression regimes defined in the total strain fixed crack model [31].

To represent the physical nonlinear behaviour, a total-strain fixed crack model was adopted [31]. This approach makes it possible to describe the tensile, compression, and shear nonlinear behaviour for a continuum model. Failure is initiated when the principal stresses reach the maximum allowable (material tensile strength) stress, being the cracks orthogonal to the principal stresses direction. The initial cracking orientation is maintained as fixed despite the possible variation of the principal stresses direction during the loading process (see [31], [44]). Such assumption follows, in fact, the physical nature of cracking. A shear retention value has been defined as 0.1. The diagrams that represent each material in terms of stress–strain relationship were also defined. In the present case study, only masonry and concrete elements are assumed to have material nonlinearity and its behaviour given by a parabolic stress–strain relationship for compression and an exponential stress–strain relationship for tension behaviour, see Fig. 5.

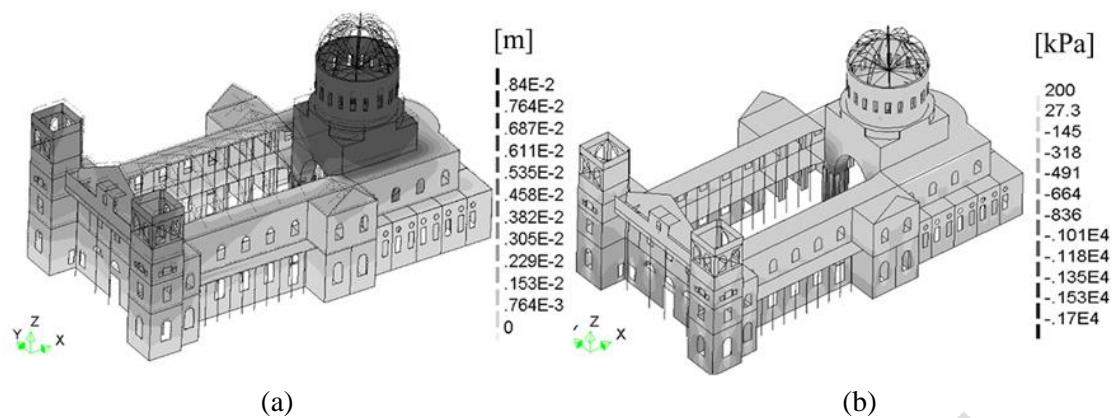
Fig. 6 – Results of the analysis due to the gravitational loads: (a) Total displacements; (b) Vertical stresses.

A linear static analysis of the Christchurch Catholic Basilica for the gravitational loads was performed, aiming at evaluating the mesh of the model, the displacements, and the stress concentrations. Fig. 6(a) presents the structural deformation, in which it is observed that the maximum displacement is approximately equal to 8 mm and occurs in the solid elements, that is, elements above the sanctuary. It is also noted that larger displacements occur in the second-floor slabs that are connected to the rotunda walls.

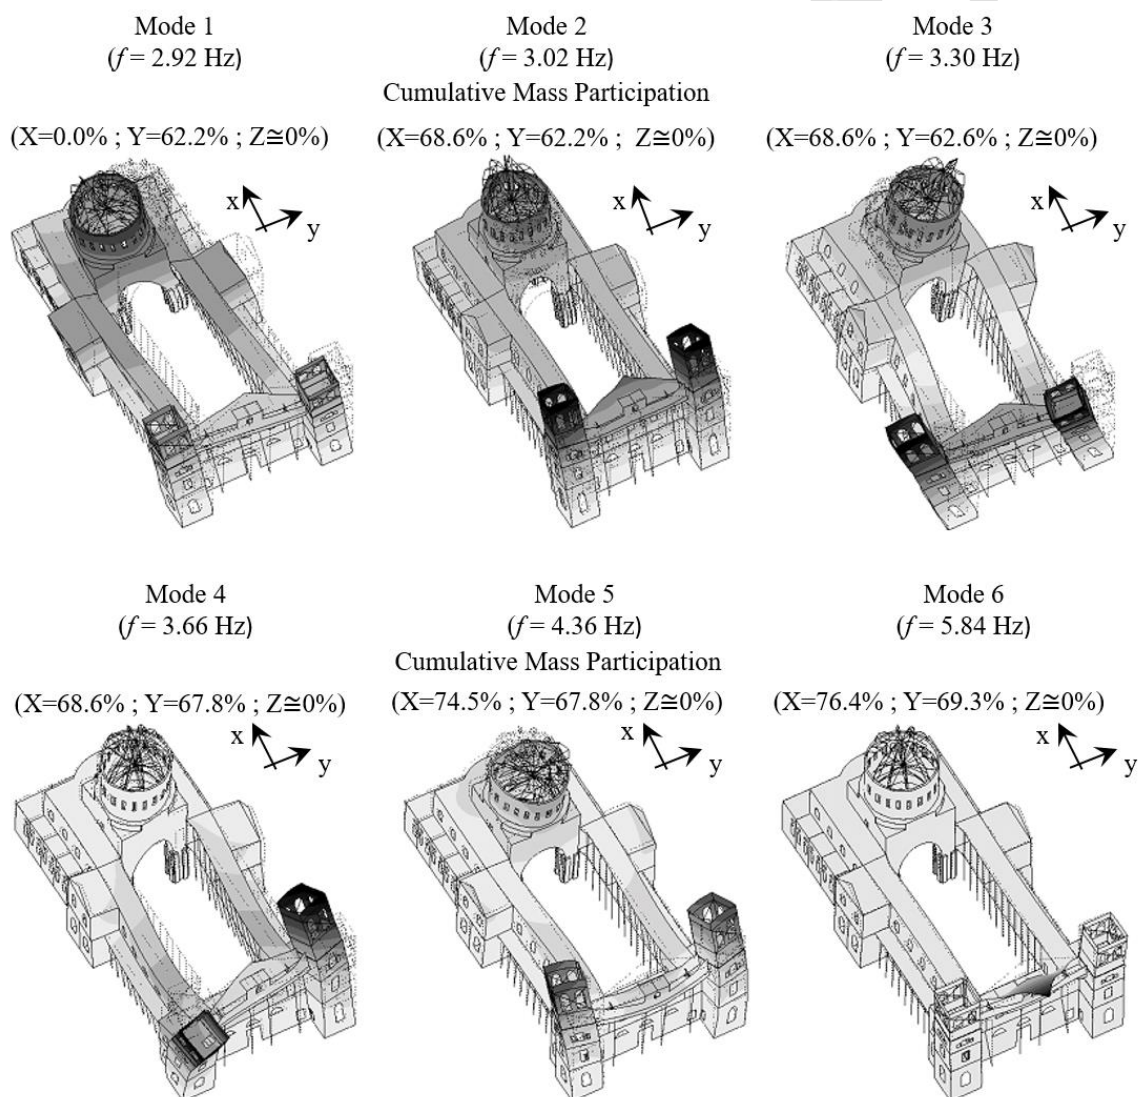
Fig. 7 – First six global mode shapes and cumulative mass participation for the non-damaged structure (the roof truss beams are not depicted for clarity reasons).

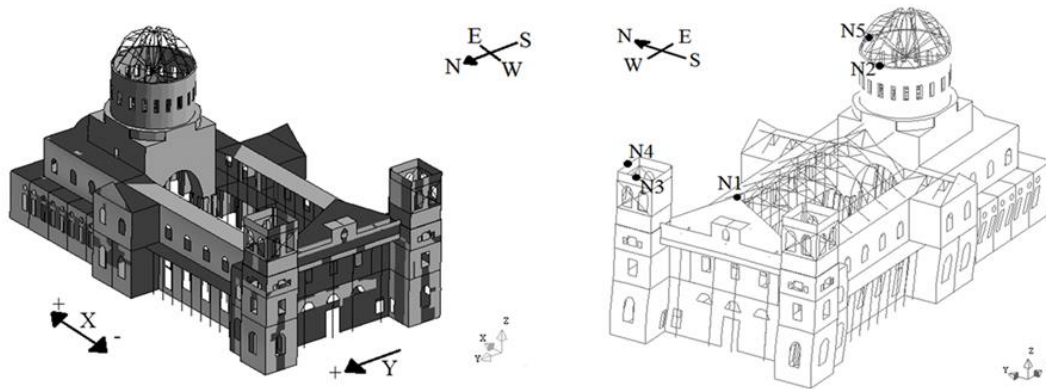
Fig. 8 – Directions and control nodes for the pushover analysis: (a) Applied load directions (longitudinal, X; transversal, Y); (b) Control nodes used for evaluating the response of the structure.

The control nodes assumed for the pushover analysis in the longitudinal direction +X are located at the west tympanum wall (node 1), at the top of the main dome (node 2), and at the top of the bell tower (node 3) (Fig. 8). The capacity curves are presented in Fig. 9. All the control nodes have a marked nonlinear behaviour, in which the linear limit (onset of cracking) occurs for a load factor of about 20% of the gravity acceleration (0.20 g). The top of the tympanum west wall (node 1) has a larger horizontal displacement than the main dome node (node 2) and the bell tower node (node 3). A maximum horizontal load of about 66% of the structure self-weight (0.66 g) was applied.

In the pushover analysis in the transversal +Y direction, different control nodes were used, namely nodes 4 and 5, since they correspond to nodes located in elements that exhibit the maximum horizontal displacement in this direction (see Fig. 8). The capacity curves show that the outset of cracking, which leads to the decrease of the initial stiffness, occurs for a lateral load value that ranges from 15 to 20% of the self-weight (Fig. 13(a)). Thus, the vulnerable elements of the structure are the bell towers. It is also observed that the main dome (node 2, according to Fig. 8b) presents the lowest horizontal displacement. The main damage obtained in the pushover analysis in the +Y direction is presented in Fig. 14. The damage pattern is similar, as expected, for the horizontal load equal to 0.22 g (September 2010 earthquake) and 0.45 g (approximately equal to the PGA of the February 2011 earthquake). Nevertheless, the structure presents low damage for the load coefficient of 22% of the self-weight and thus only the damage that occurs for a horizontal load equal to 0.45 g is presented.

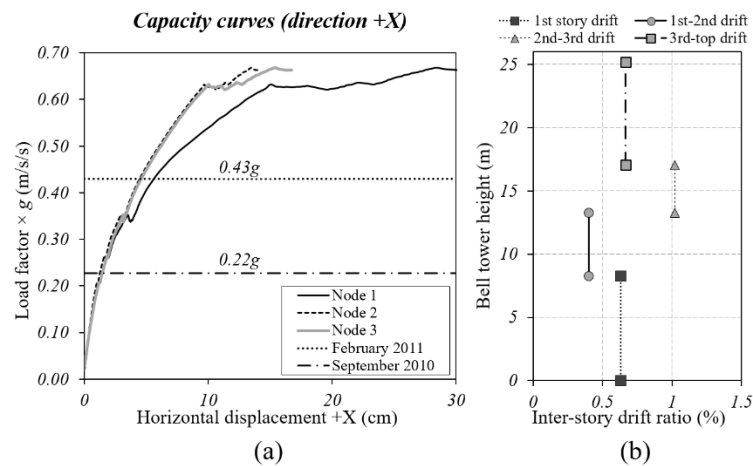
Fig. 9 – Pushover analysis in the longitudinal direction +X: (a) Capacity curves for control nodes 1, 2, and 3; (b) Inter-storey drifts ratio of the bell towers for the maximum load factor applied.

The behaviour and damage assessment of the structure for the seismic events of both September 2010 and February 2011 was assessed by considering the applied horizontal load to be equal to the registered PGA values [34] of the Christchurch recording station (see Section 2.2). The maximum displacement is 23 mm for the September earthquake (node 1, 2 and 3) and 69 mm (node 1) for the February 2011 earthquake; see Fig. 9(a). For both earthquakes, the larger displacements are located on the top of the elements. However, the horizontal relative displacements do not present a linear increase in elevation. The first-floor walls present a significant in-plane displacement (and damage), which is observed from the inter-storey drifts and the deformed shape of the bell tower (Fig. 9(b)).

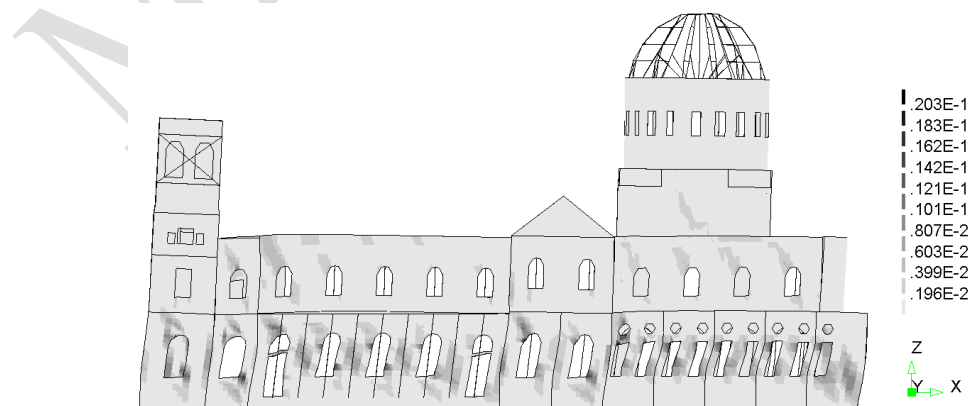
Fig. 10 – Principal tensile strains in the south façade walls for the pushover analysis in the longitudinal +X direction (February 2011 earthquake, 0.43 g). (The nave roof frame is not represented).

The principal tensile strains that occurred in the south façade are in agreement with the displacement-based results. For a PGA of 0.22 g, which represents the seismic event of September 2010, minor cracks are observed around the first-floor openings. However, for a PGA of 0.43 g, the severity of the damage increases (Fig. 10). It is observed that the damage, caused by in-plane shear stress, is concentrated in the first-floor walls, that is, in the openings and the wall connections (shell elements). The latter is especially observed in the bell towers. In fact, the elements added in the 2004 strengthening works, namely the RC slabs in the bell towers and nave, as well as the steel braces and ring beams of the third floor of the bell tower, improve the seismic behaviour of the structure (see Fig. 9). However, once no strengthening measures were considered at the first floor, the damage tends to be localized at these masonry walls (as depicted in Fig. 10).

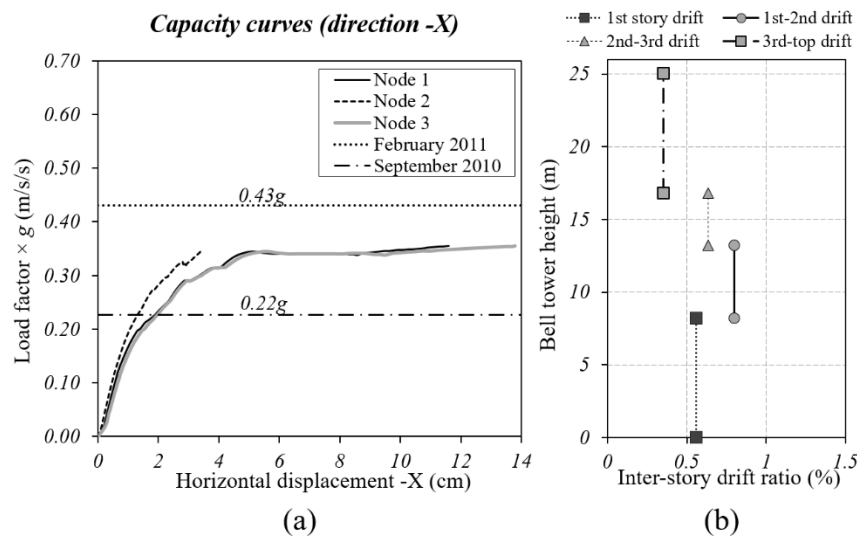
Fig. 11 – Pushover analysis in the longitudinal direction –X: (a) Capacity curves for control nodes 1, 2, and 3; (b) Inter-storey drifts ratio of the bell towers for an applied load factor equal to 0.35 g.

In the pushover analysis in the longitudinal direction –X, the control nodes 1, 2, and 3 were considered. The capacity curves (Fig. 11) show that the west tympanum wall (node 1) and the bell towers (node 3) are the most vulnerable elements found in this analysis. The last elements have a marked nonlinear behaviour, in which the linear limit (initial cracking) occurs for a load factor of about 15%. The maximum horizontal load factor applied in this analysis is equal to 0.35 g due to convergence issues. For this load level the west façade tympanum and the bell towers reach their maximum load capacities (nodes 1 and 3), causing difficulties in the solution convergence of the system equilibrium equations. The results show that the west gable wall and the bell towers have lower strength capacity in the –X direction. This can be explained by the confinement action caused by the rotunda walls, which occurs in the +X direction (the confinement is only possible due to the modelled roof trusses). This behaviour does not occur for the –X direction, because the out-of-plane movement of the west façade tympanum leads to tensile stresses that cannot be withstood by the rotunda walls, due to the low tensile strength of masonry elements.

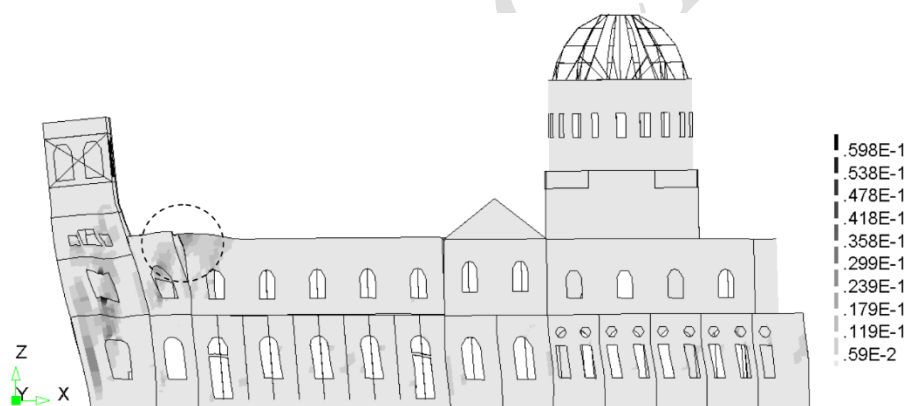
Fig. 12 – Principal tensile strains at the south façade walls for the pushover analysis in the longitudinal – X direction (0.35 g). (The nave roof frame is not represented).

The crack pattern is similar to the damage obtained in the pushover analysis in the +X direction, that is, a high concentration of cracks in the north and south walls (nave and sacristy) near the openings (Fig. 12). The longitudinal façades present damage caused by in-plane shear stresses. Therefore, the main difference in the in-plane behaviour of the

longitudinal façades found in the pushover analysis in the +X and -X direction corresponds to the way in which diagonal shear cracks propagate. It is also important to refer to another difference in the damage pattern, highlighted in Fig. 12 by a dashed circle, which corresponds to the damage at the connection between the south nave and south stairwell wall. This is not related to a shear action but is instead caused by the pushover action in these elements (tensile stresses). Thus, if the pushover analysis in the +X direction causes moderate damage in the bell tower walls, the pushover analysis in the -X direction creates a crack pattern prone to an out-of-plane failure mechanism.

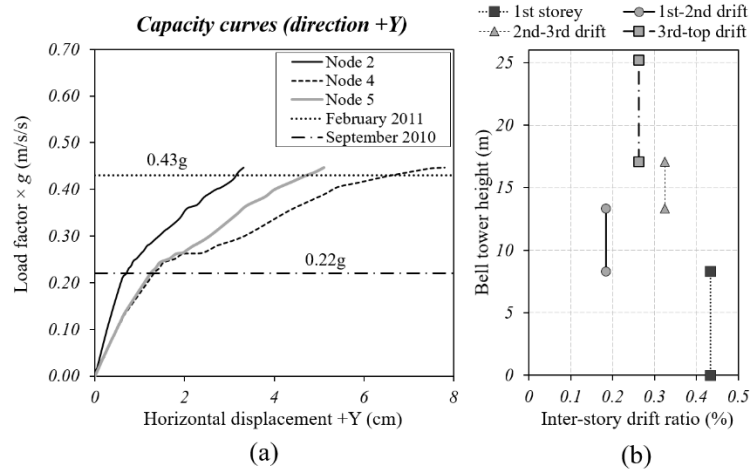
Fig. 13 – Pushover analysis in the transversal direction +Y: (a) Capacity curves for control nodes 2, 4, and 5; (b) Inter-story drifts ratio of the north bell tower for an applied load factor equal to 0.45 g.

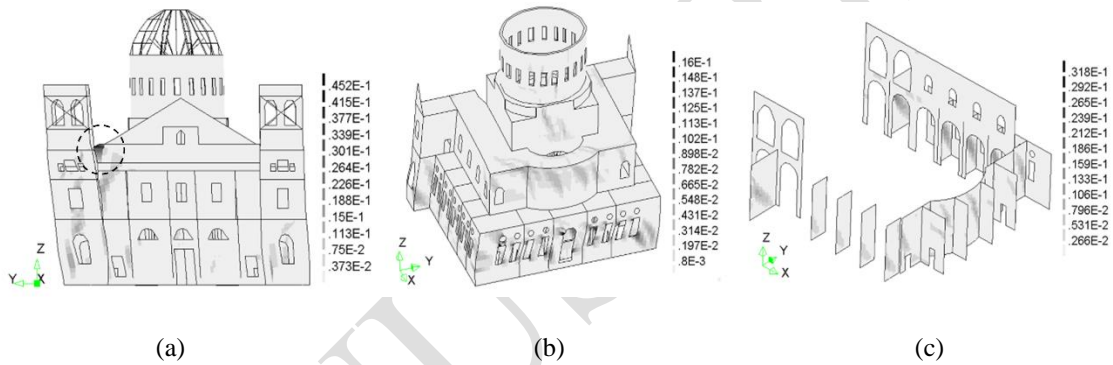
Fig. 14 – Principal tensile strains for the pushover analysis in the transversal direction +Y for a horizontal load equal to 0.45 g (approximately equal to the PGA of the February 2011 earthquake): (a) West façade; (b) East façade, rotunda, main dome and exterior slabs; (c) Damage to the interior transverse walls.

Fig. 14(a) shows that the concentration of tensile stresses occurs at the top of the connection between the façade and the north bell tower. A set of diagonal cracks is also observed in Fig. 14(b), due to in-plane shear stresses near the openings of the west and

east elevations and near the wall connections, mainly in the transversal walls of the transepts and in the second floor of the east wall. The Basilica also presents cracking at the second-floor slab near the east rotunda wall, as well as damage at the south, east, and west rotunda walls (Fig. 14(b)). The same type of damage also occurs in the four large piers, which present horizontal cracking due to tensile stresses caused by the outward movement (bending).

Furthermore, diagonal shear cracks are very clear in the transversal walls of the south and north façades. There is no occurrence of toe crushing and, similarly to what occurs in pushover analyses in the longitudinal direction, the difference between displacements of the first and second storeys is considerable, being the main cause of the concentration of shear cracks at the first floor of both bell tower walls. In addition to the damage already reported, there is a lower capacity to dissipate energy in the transversal direction, and the transversal interior walls present damage (Fig. 14(c)).

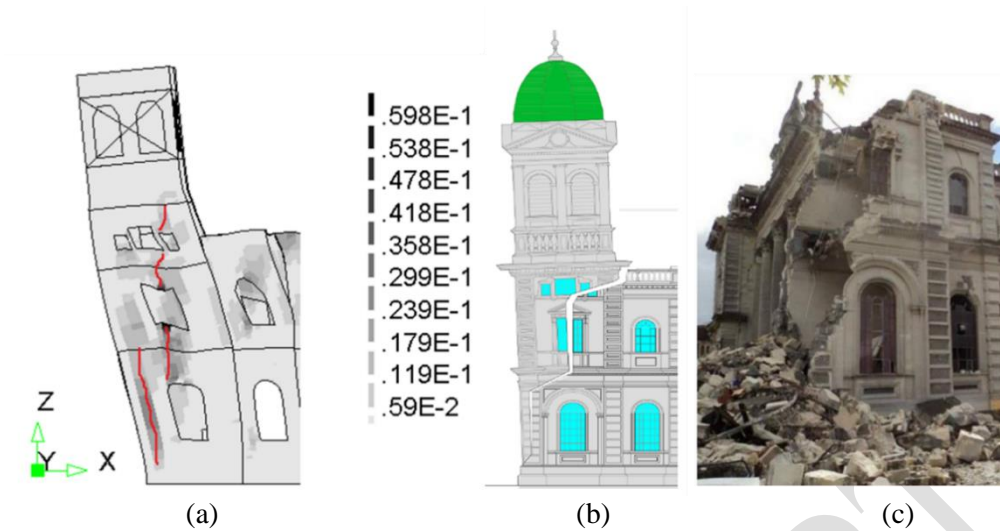
Fig. 15 – Bell towers failure mechanism: (a) Numerical damage for the horizontal load equal to 0.35 g (–X direction); (b) and (c) Failure mechanism observed after the collapse of the south bell tower.

The axial design force of the steel tie beams was derived from the concept of limit analysis bearing the bell towers overturning mechanism from Fig. 15a [77]. The ties may assure the masonry towers equilibrium for, at least, a lateral load capacity of 0.43 g, i.e. the assumed reference value. The maximum allowable tie stress is given by the elastic resistance defined by the design steel grade (yield tensile strength of 190 MPa) [78]. The dimensions of the plates were designed to avoid failure of: (i) the steel components, i.e. punching of the plate [78] ; and (ii) failure by masonry pull-out, i.e. the so-called masonry cone-breakout according to [79]. Note that the design of the latter systems is an iterative procedure, meaning that the design force was verified and validated after performing the quasi-static analysis.

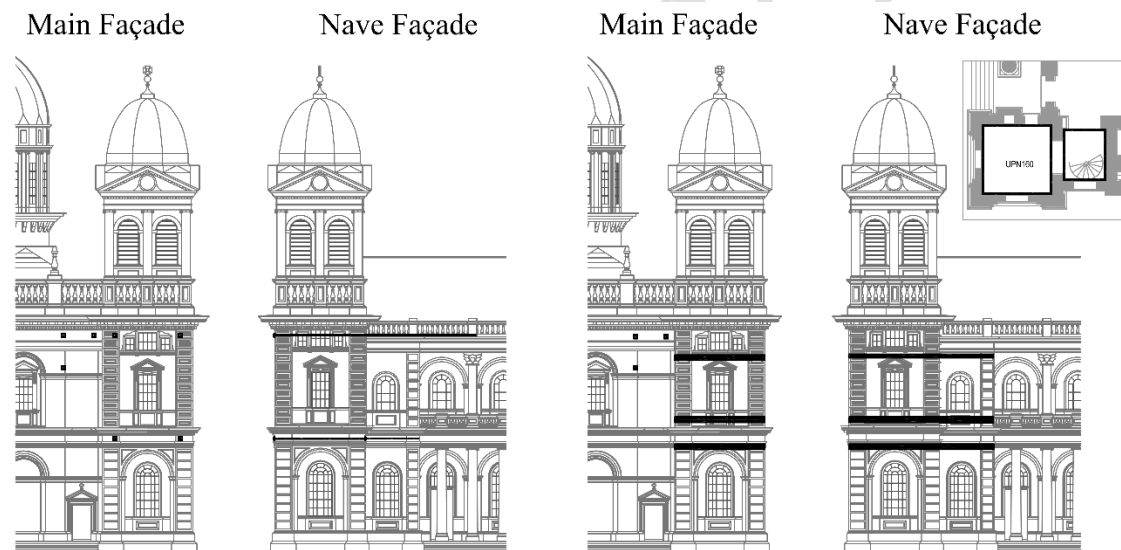
Fig. 16 – Strengthening proposals: (a) First proposed intervention with stainless steel tie rods; (b) Second proposed intervention with steel ring beams and three tie rods at the main façade.

In the first strengthening proposal, a set of stainless steel tie rods with 12-m-long are applied to the structure at the level of the floors being anchored in the slabs. The aim is to improve the connection between orthogonal walls, allowing a better force distribution into the nave walls and preventing out-of-plane collapse of the bell towers.

This intervention is commonly used [74] and is in accordance with modern concerns, because it is reversible and brings minimal constraints and architectural interferences. The concern about corrosion is also overcome by using stainless steel tie rods. This intervention includes the application of seven stainless steel tie rods (class AISI 316L) with a diameter of 32 mm, divided into two levels, in each tower (Fig. 16(a)). The

The second strengthening proposal keeps the three tie rods of the first proposal at the main façade but includes ring beams at the bell towers instead of the stainless-steel tie rods (Fig. 16(b)). The design of the steel tie beams and respective anchor plates follow the same guidelines used for the first strengthening scheme. For the rings, after conducting several quasi-static analyses with different cross-section dimensions, stainless steel channels with a height of 180 mm (class AISI 316L) were used. These allowed to achieve the intended behaviour of the bell towers confinement and are a reasonable choice, according to the authors experience. The stresses found in the connection of the ring beams are far from the ultimate design ones, according to [78]. Yet, it may be remarked that it is assumed that its steel members should be welded to guarantee a monolithic frame (rigid connections). Its connection with the walls may be accomplished [74], [80]: (i) in the inner side of the wall, through inclined stainless steel anchorages; or

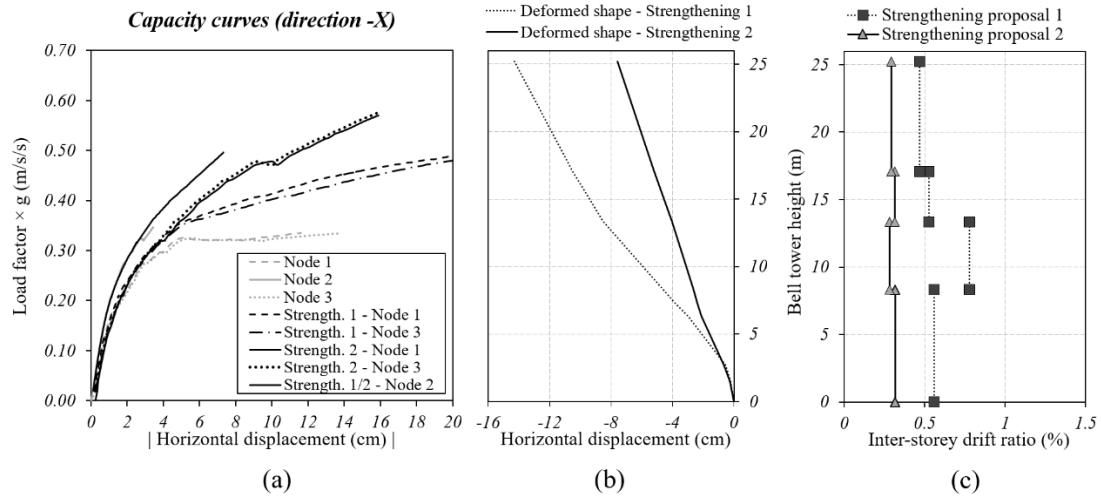
Fig. 17 – Strengthening proposals: (a) Obtained capacity curves; (b) Deformed shape at the south bell tower for a horizontal load equal to 0.43g; (c) Inter-story drifts ratio at the south bell tower for an applied load factor equal to 0.43 g.

With respect to the second intervention, a better behaviour is obtained. In fact, the use of steel rings between openings makes it possible to achieve a better monolithic behaviour by better transferring forces into the nave walls (stiffer walls in the longitudinal direction). This leads to considerably lower inter-storey displacements and a smooth deformed shape (Fig. 17(b)). Minor cracking is also observed in the strengthened model 2, similarly to the strengthened model 1, leading to the conclusion that the 12-m-long ties anchored to the

slab at the second level are efficient (see the crack line with an inclination of 45° on the second floor of the nave in Fig. 17(b)).

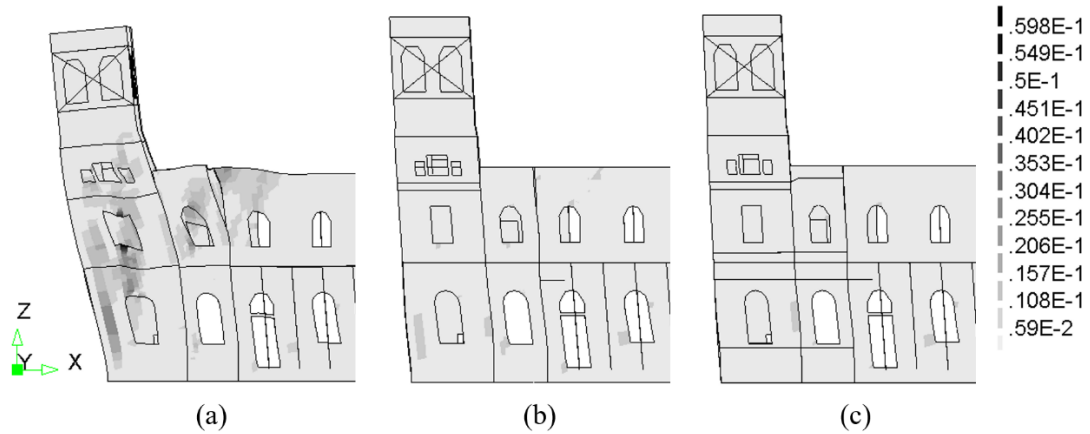
Fig. 18 – Comparison of principal tensile strains for the horizontal load equal to 0.35 g: (a) Non-strengthened model; (b) Strengthened model 1; (c) Strengthened model 2.

In what concerns the crack pattern of the non-strengthened model, the Basilica suffered severe damage to both bell towers and the vicinity walls for a horizontal load of 0.35 g (Fig. 18(a)). Extensive cracking due to in-plane shear failure is observed (note that the strain values shown are too large, indicating a fully formed mechanism. At this stage large displacements and large strains should be considered but this does not affect the conclusions obtained or the peak capacity values). The bell tower presents a maximum principal strain of 0.0598 around the first storey window, which can activate the out-of-plane failure mechanism observed after the earthquakes (see Fig. 3b). It is expected that the interventions could prevent the formation of the later failure mechanism and thus the bell towers collapse. Fig. 18(b) and (c) show that the results are in accordance with what was expected, with insignificant damage being observed at the bell tower walls. Hence,

the strengthening measures distribute the loads to the nave walls and nave slabs, causing more damage to these elements, namely some cracks in the first floor of the nave.

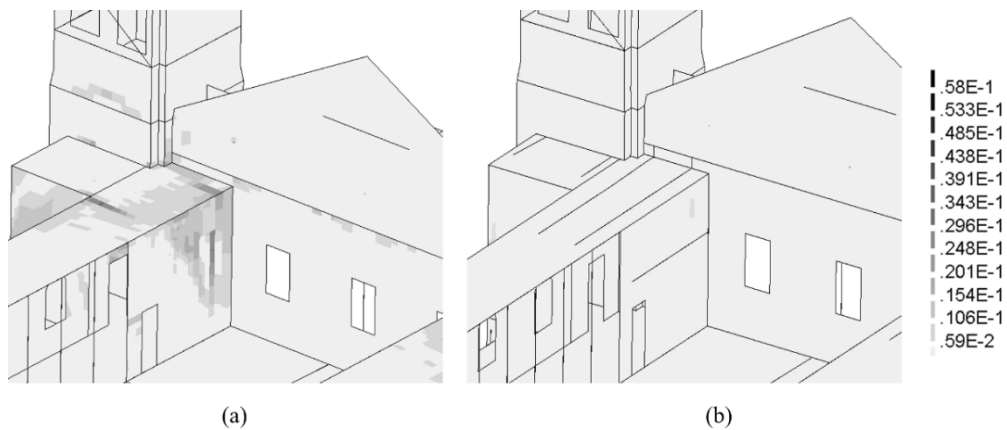
Fig. 19 – Details of the principal tensile strains for the horizontal load equal to 0.35 g: (a) Non-strengthened model; (b) Strengthened model 1.

Considerable differences in the damage to the interior walls are also presented. In the non-strengthened structure (Fig. 19(a)), the occurrence of damage in the interior walls and second-floor slab is clear. However, the severity of the damage decreases significantly for the strengthened models; see Fig. 19(b) (the results for the two interventions are similar).

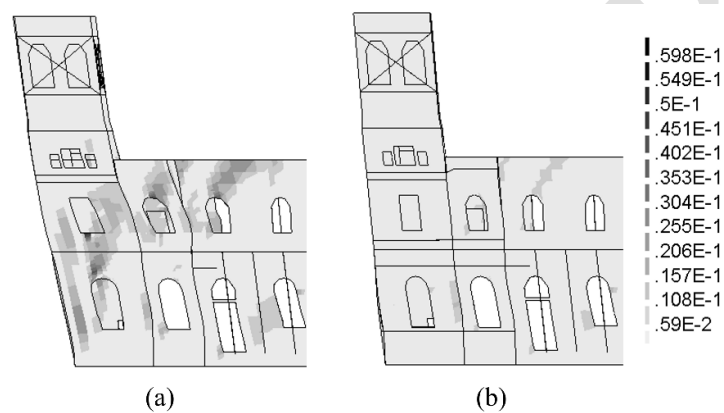
Fig. 20 – Comparison of principal tensile strains for the horizontal load equal to 0.43 g: (a) Strengthened model 1; (b) Strengthened model 2.

Finally, the seismic performance of the structure with the strengthening proposals incorporated was also evaluated for a horizontal load equal to 0.43 g, which represents the PGA of the February 2010 earthquake. Fig. 20 presents the principal tensile strains, from which it can be observed that the first strengthening model suffers more damage than the strengthening model 2. Moderate damage is also present in the first floor, with severe cracking around the openings, which is a pattern of damage similar to the obtained with the unstrengthen model in Fig. 18a. Some crack is also visible in the second floor, which it is explained by the difference in stiffness of the elements, mainly due to the RC bond beams added at the third floor. Thus, the strengthening proposal 1 is an effective solution as it creates new loads paths and delays failure. However, it does not provide sufficient strengthening to change the condition of the bell towers as the most vulnerable elements.
